Case Histories in Ultrasonic Testing.

V Prasad, M. M. Gautam, C. Satheesh, and P.V Varde

Research Reactor Services Division
Bhabha Atomic Research Centre
vprasad@barc.gov.in

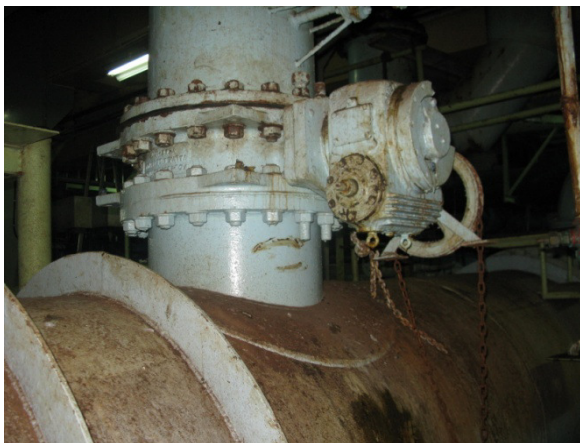
Fig.1-Chain & wheel operated butterfly valve the heat exchanger (PW/SW Hx #5)

incomparison to other online Hxs. Reason suspected was the reduced sea water flow through the heat exchanger#5. Though all the valve positions were checked to be as intended by its position indicators, doubts were expressed about the disengagement of outlet butterfly valve disc from its actuator resulting in incomplete opening. It was required to know the exact location of butterfly valve disc in *as it is* condition without disturbing the operation of the system in order to plan the maintenance activities.

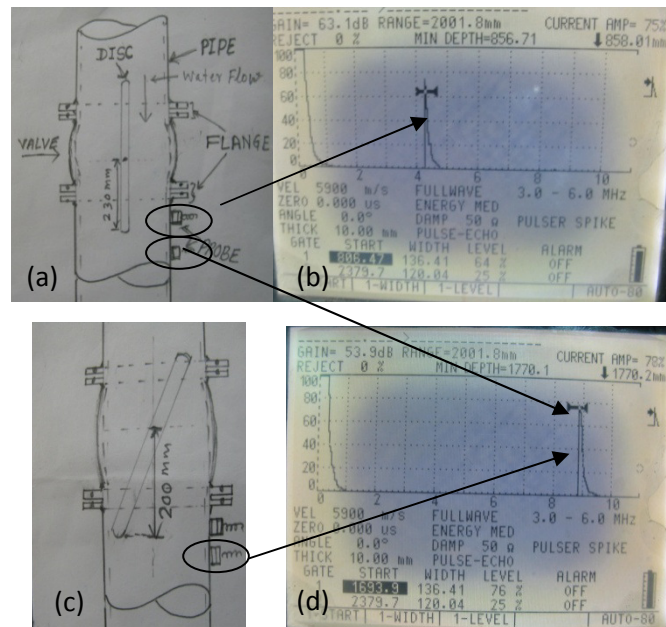
Site testing was carried out initially by employing pulse-echo method with scanning of sea water outlet line of Hx #5 at different elevations on either side of the valve. Similar scanning was also carried out in Hx. #4 for comparison purpose. Upstream side testing indicated weak signals, probably due to bio fouling inside or liner degradation and hence downstream side was used for scanning. Back wall echo appeared beyond a distance of 230 mm from the centre of the valve for Hx #4 (Fig. #3 a & d) while it was beyond 200 mm for Hx. #5 (Fig. #3 c & d). An intermediate echo was also observed within

230 mm from the centre of the valve

Fig.3, a & c – Probe positions on the downstream of the valve; b- Echo when sensor put within 230 mm of fully open valve; d –Echo when sensor put beyond the flapper disc either full or partial open.

for Hx. #4 (Fig. 3 b), while no such echosignal was noticed in case of Hx #5 valve. When through transmission technique was tried, a clear water path echo also appeared beyond 230 mm for Hx. #4 and at 200 mm for Hx. #5. Loss of water path echo before 230 mm for Hx#4 and before 200 mm for Hx#5 ensured the availability of clear path inside. This testing required proper aligning the two sensors diametrically opposite sides. This conclusively proved that Hx#5 outlet valve opened upto maximum of 200mm from the centre as against the normal of 230mm. Subsequently, on dismantling the valve, its locking key of the disc shaft with drive mechanism found disengaged and valve position was remaining in partially open condition.

After repairing the valve disc, the same method was again tried for various valve openings and the observations indicated that the trajectory of valve tip could be correctly identified by the above two methods beyond flange locations.

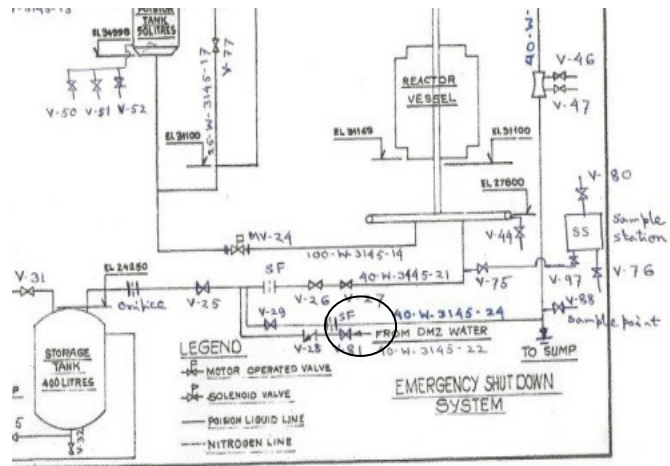
Emergency Shutdown System (ESD) of Dhruva reactor consists of twenty poison tubes, top and bottom headers, buffer tank, poison storage tank, valves and associated pipe lines of various diameters (Fig. -4). To keep the system healthy and dry, He/N₂ gas purging is carried out regularly. There was a case of increased radiation field in the poison storage tank room. Also while carrying out of flushing of line through drain line, no helium gas was coming out from the downstream side of the drain valve #27 (Fig. 4). All valve line up was checked to be as desired. It was required to identify the

reason for blockage of Helium flow and increased radiation field.

Fig.4, Flow diagram(part) of ESD Mock-up trials

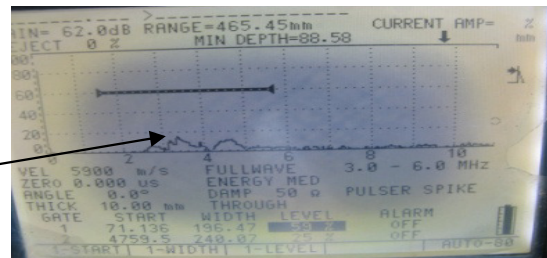
a) Empty Pipe,
 b) Pipe filled with Water and
 c) Pipe filled with fine sand and water
 Empty pipe showed only wide banded echoes/noise signal (Fig 6 a). Water filled pipe showed the echoes at water path distance approximately 148 mm (Fig 6b). The pipe filled with fine sand and water showed echo amplitude of 15-20 % FSH (Full Scale Height) at 138 mm approximately (Fig 6 c).

(a) Echo from empty piped

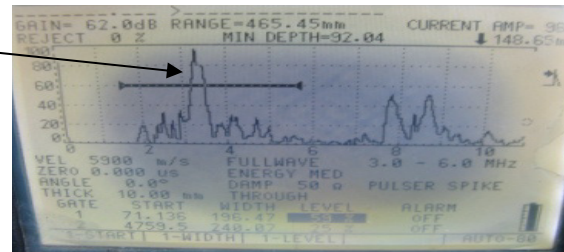
(b) Echo Through water

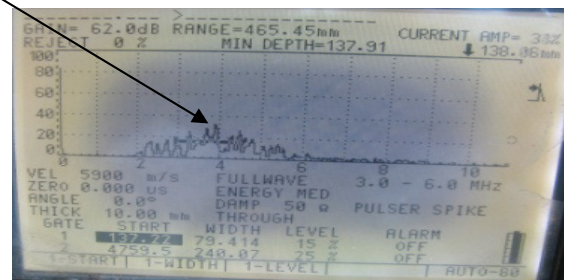
Fig. 6 (c) Echo through sand

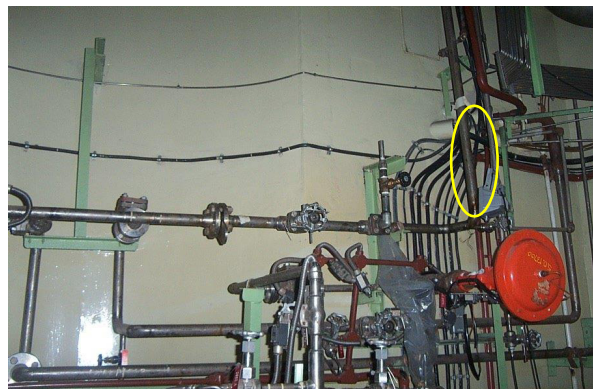
The inspection was carried out in two phases. Initial trials were done to locate areas where good echoes of water path were obtained by scanning upstream side of the valve #27 marked in Figs. 4. Clear signals started appearing on the vertical portion of the line after a height of 2' from the elbow (Fig. 7). This indicated the bottom level of the holdup water below which obstructions (blockage) could be present. In the next phase, the blockage area was

scanned downwards using 2.25 MHz sensor. The amplitude of ultrasonic echo from the above mentioned level (2' above the elbow) reduced to <10% of FSH. Similar signals were obtained till the valve end showing the extent of blockage. Both pulse-echo and through transmission methods gave similar observations. The above observations conclusively identified the

Fig.7 Choked line marked

location and the extent of the choking in the line. Subsequently, pipe line was opened and choking material was removed.
