Extended Major Turn Around at Heavy Water Plant (Kota) - A Great Challenge

R.D.Patel^{1, a} and I. Maria Michael Raj^{2, b}

¹Associate Director (O), Heavy Water Board, Mumbai

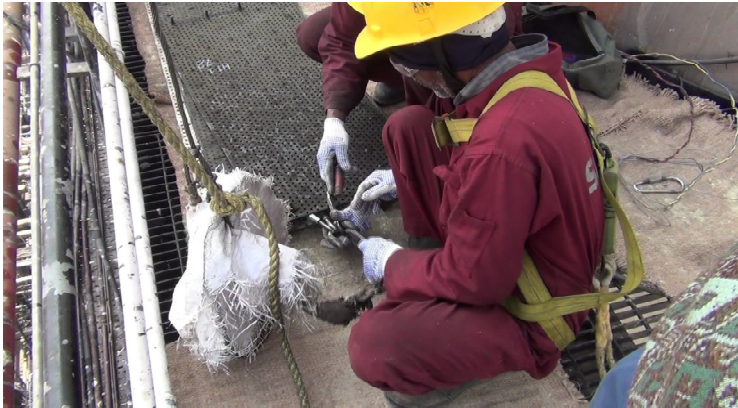
TOWER TRAY BEING SHIFTED

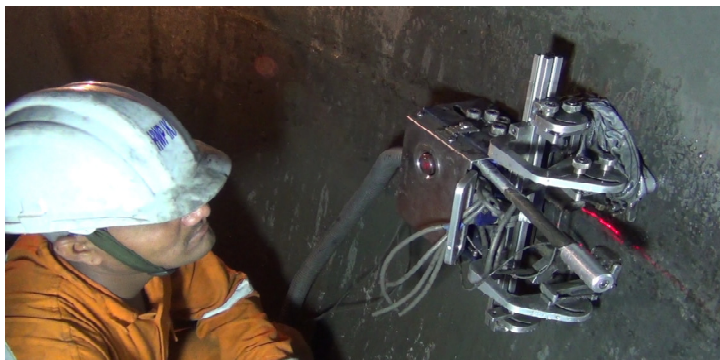
PHASED ARRAY UT

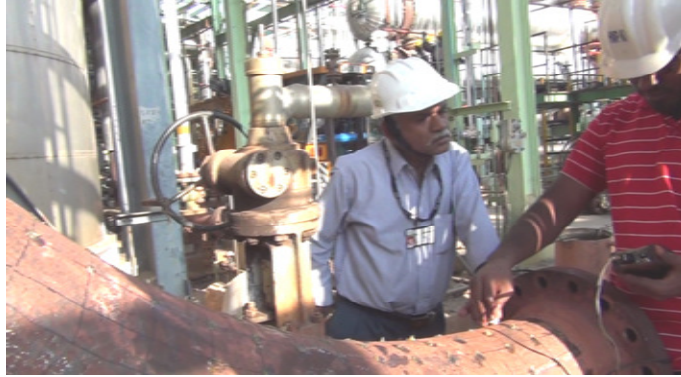
ULTRASONIC THICKNESS MAPPING

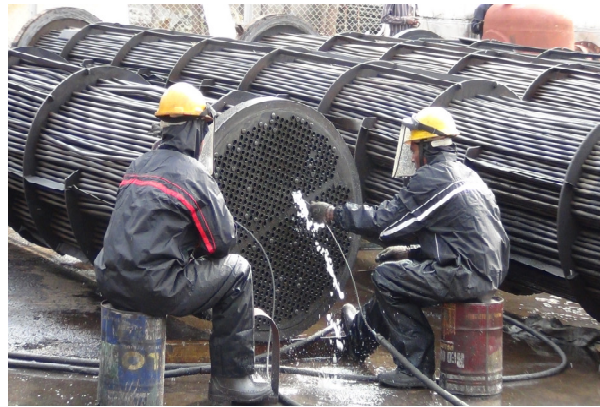
HX MAINTENANCE
