Case Histories in Ultrasonic Testing.

M. M. Gautam, V Prasad, C. Satheesh, and P.V Varde

Research Reactor Services Division
Bhabha Atomic Research Centre
yprasad@barc.gov.in

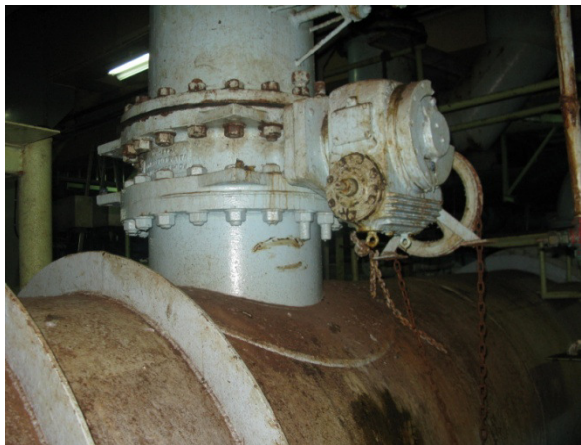
Fig.1-Chain & wheel operated butterfly valve

Dhruva reactor has got 6 nos. of Process water/Sea water heat exchangers to transfer reactor heat to sea water system. These heat exchangers are installed in parallel across two headers (CS 900 mm dia. sea water side)(fig.1)Chain & wheel operated butterfly valves are provided on either side of heat exchangers for isolation. These heat exchangers are not provided with individual flow measuring instruments, though individual temperature and gross flow measuring instruments are available. There was a case of reduced differential temperature of process water across one of the heat exchanger (PW/SW Hx #5) in

comparison to other online Hxs. Reason suspected was the reduced sea water flow through the heat exchanger#5. Though all the valve positions were checked to be as intended by its position indicators, doubts were expressed about the disengagement of outlet butterfly valve disc from its actuator resulting in incomplete opening. It was required to know the exact location of butterfly valve disc in *as it is* condition without disturbing the operation of the system in order to plan the maintenance activities.

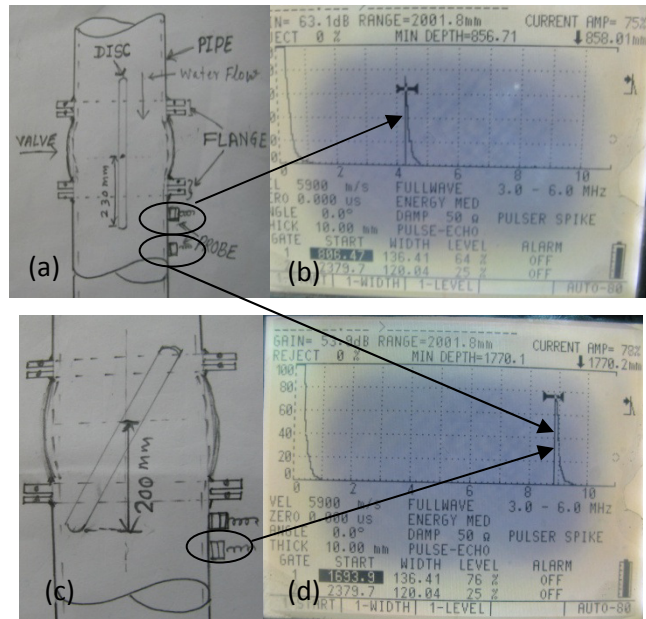
Site testing was carried out initially by employing pulse echo method with scanning of sea water outlet line of Hx #5 at different elevations on either side of the valve. Similar scanning was also carried out in Hx. #4 for comparison purpose. Upstream side testing indicated weak signals, probably due to bio fouling inside or liner degradation and hence downstream side was used for scanning. Back wall echo appeared beyond a distance of 230 mm from the centre of the valve for Hx #4 (Fig. #3 a & d) while it was beyond 200 mm for Hx. #5 (Fig. #3 c & d). An intermediate echo was also observed within

230 mm from the centre of the valve
 Fig.3, a & c – Probe positions on the downstream of the valve; b- Echo when sensor put within 230 mm of fully open valve; d –Echo when sensor put beyond the flapper disc either full or partial open

for Hx. #4 (Fig. 3 b), while no such echo signal was noticed in case of Hx #5 valve. When through transmission technique was tried, a clear water path echo also appeared beyond 230 mm for Hx. #4 and at 200 mm for Hx. #5. Loss of water path echo before 230 mm for Hx#4 and before 200 mm for Hx#5 ensured the availability of clear path inside. This testing required proper aligning the two sensors diametrically opposite sides. This conclusively proved that Hx#5 outlet valve opened upto maximum of 200mm from the centre as against the normal of 230mm. Subsequently, on dismantling the valve, its locking key of the disc shaft with drive mechanism found disengaged and valve position was remaining in partially open condition.

After repairing the valve disc, the same method was again tried for various valve openings and the observations indicated that the trajectory of valve tip could be correctly identified by the above two methods beyond flange locations.

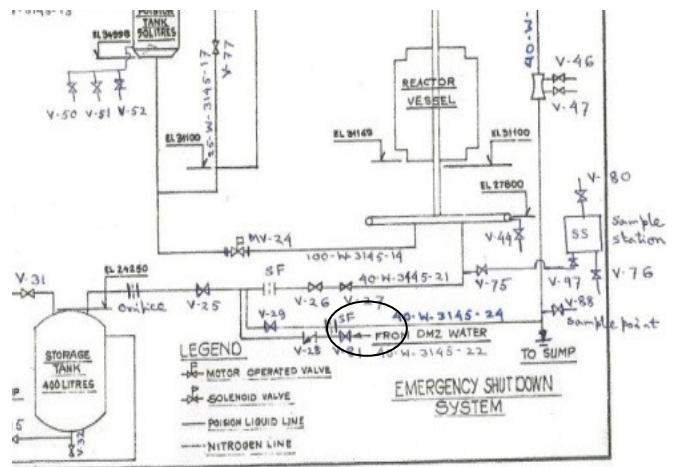
Fig 4. Flow diagram (part) of ESD presence of water in those areas.

Emergency Shutdown System (ESD) of Dhruva reactor consists of twenty poison tubes, top and bottom headers, buffer tank, poison storage tank, valves and associated pipe lines of various diameters (Fig. -4). To keep the system healthy and dry, He/N₂ gas purging is carried out regularly. There was a case of increased radiation field in the poison storage tank room. Also while carrying out of flushing of line through drain line, no helium gas was coming out from the downstream side of the drain valve #27 (Fig. 4). All valve line up was checked to be as desired. It was required to identify the reason for blockage of Helium flow and increased radiation field.

The drain lines are of 40 mm dia and made of stainless steel. The outer side was clean and accessible for inspection. As the purge gas flow could not pass through, tight plugging of the line was suspected from the inner side and an ultrasonic method was considered for detecting the choking in the line. When a preliminary normal beam testing of the line was taken up in the area where high radiation field was observed, water path signals could be observed at some locations when instrument ranges was fixed at 500 mm. This indicated

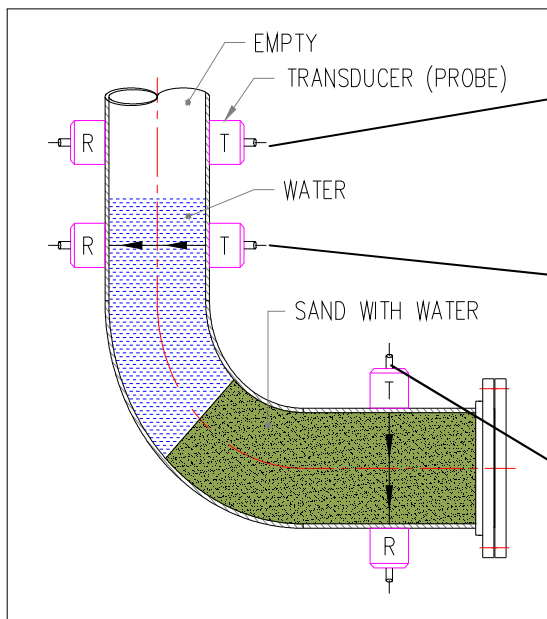
Fig.5 - Pipe filled with fine sand and water

Mock-up trials were organized using Perspex shoes suitable for 40 mm Ø pipe and 16 mm Ø, 2.25 MHz sensor. An SS pipe segment of about one meter length closed at one end (Fig.-5) was utilised for calibration and trials along with M/s Panametric make 'Epoch-4' UT flaw detector. Both through transmission and pulse echo techniques were utilised during the trials in following three conditions;

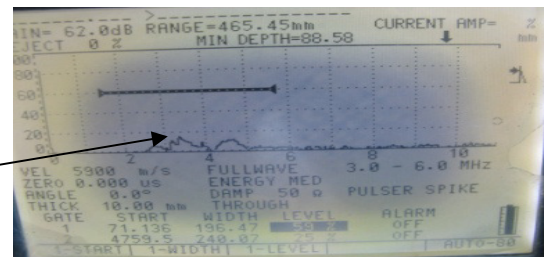
c) Pipe filled with fine sand and water
 Empty pipe showed only wide banded echoes/noise signal (Fig 6 a). Water filled pipe showed the echoes at water path distance approximately 148 mm (Fig 6b). The pipe filled with fine sand and water showed echo amplitude of 15-20 % FSH (Full Scale Height) at 138 mm approximately (Fig 6 c).

(a) Echo from empty piped

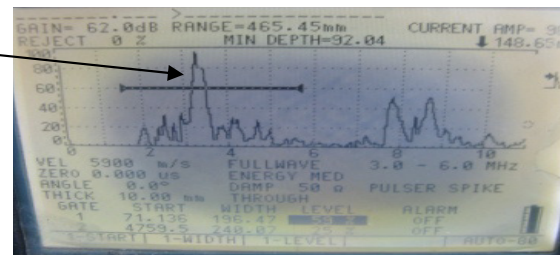
(b) Echo Through water

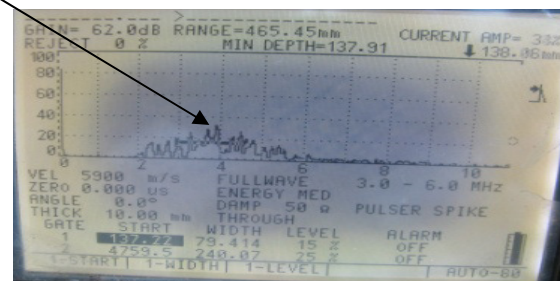
Fig. 6 (c) Echo through sand

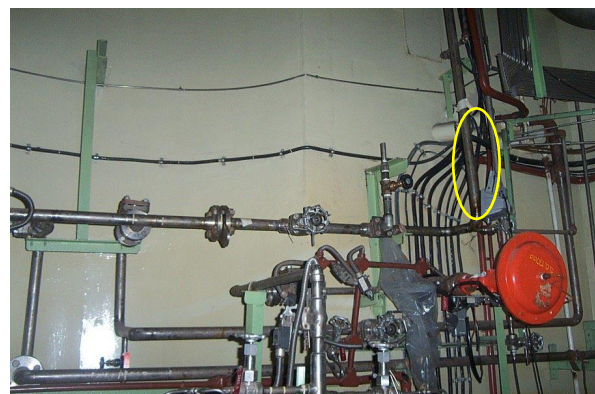
Site Testing and observations:
 The inspection was carried out in two phases. Initial trials were done to locate areas where good echoes of water path were obtained by scanning upstream side of the valve #27 marked in Figs. 4. Clear signals started appearing on the vertical portion of the line after a height of 2' from the elbow (Fig. 7). This indicated the bottom level of the holdup water below which obstructions (blockage) could be present. In the next phase, the blockage area was scanned downwards using 2.25 MHz sensor. The amplitude of ultrasonic echo

from the above level (2' above the elbow) reduced to <10% of FSH. Similar signals were obtained till the valve end showing the extent of blockage. Both pulse-echo and through transmission methods gave similar observations. The above observations conclusively identified the location and the

Fig. 7 Choked line in the extent of the line.

Subsequently, pipe line was opened and choking material was removed.
