## Identification of leakage in plate type Air Preheater using ultraviolet light test

*K N Amin*

*Inspection Dept., GNFC Limited*  
9974706212, [knamin@gnfc.in](mailto:knamin@gnfc.in)

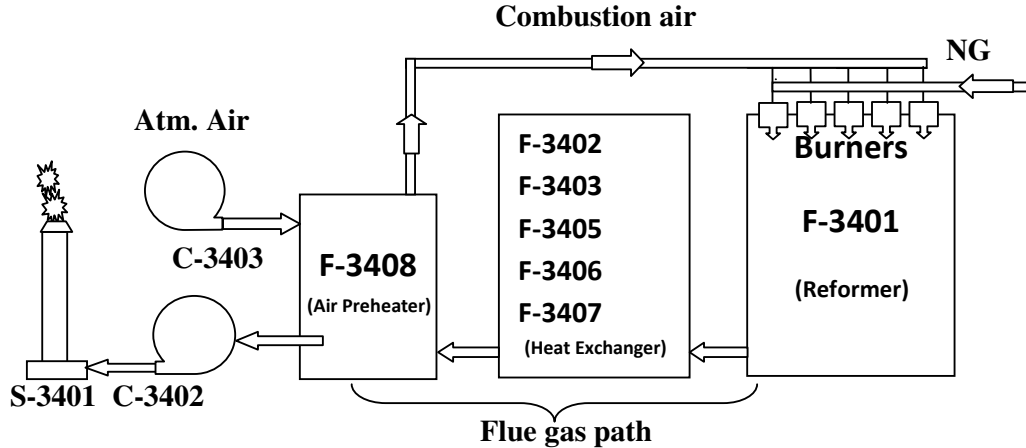
**Figure-1: Schematic diagram of process overview of Reformer**

The hot air needed for combustion in burners is being supplied from Forced Draft Fan (FD Fan, C-3403). The air from FD Fan passes through plate type Air Preheater where it achieves temperature of @460<sup>0</sup>C. This hot air supplied to burners where it ignites natural gas and finally produces combustion gas which supplies heat to reformer gas through reformer tubes. This combustion gas leaves reformer house and

passing through numbers of heat recovery units. Finally, it passes through Air Preheater and vent in to atmosphere (Stack, S-3401) using Induced Draft Fan (ID Fan, C-3402). Schematic diagram of process overview is as shown in Figure-1.

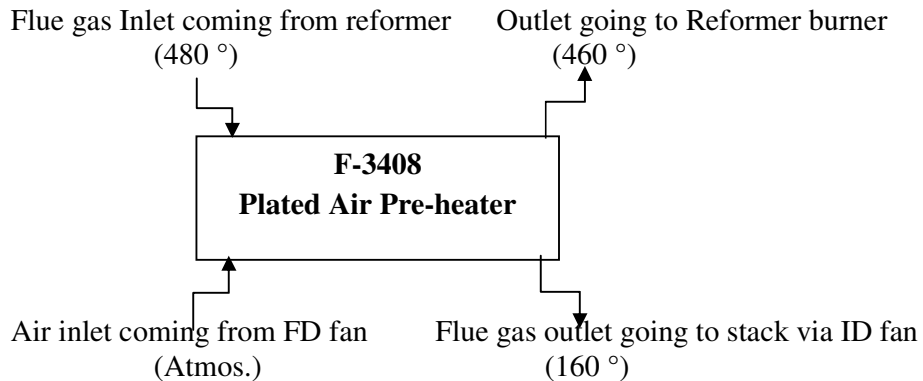
**Figure-2: Schematic diagram of air & flue gas circuits in Air Preheater**

Pre-heater Tag No.	- F-3408
Service	- Atmospheric Air & Combustion Gas
Nos. of modules	- 05
Air inlet temperature	- Atmospheric
Air outlet temperature	- 460 <sup>0</sup> C
Flue gas inlet temperature	- 480 <sup>0</sup> C
Flue gas outlet temperature	- 160 <sup>0</sup> C

Damage anticipated in Air Preheater which allows atmospheric air to short circuit to ID Fan through leaky module. This affects the complete process of plant in following ways:

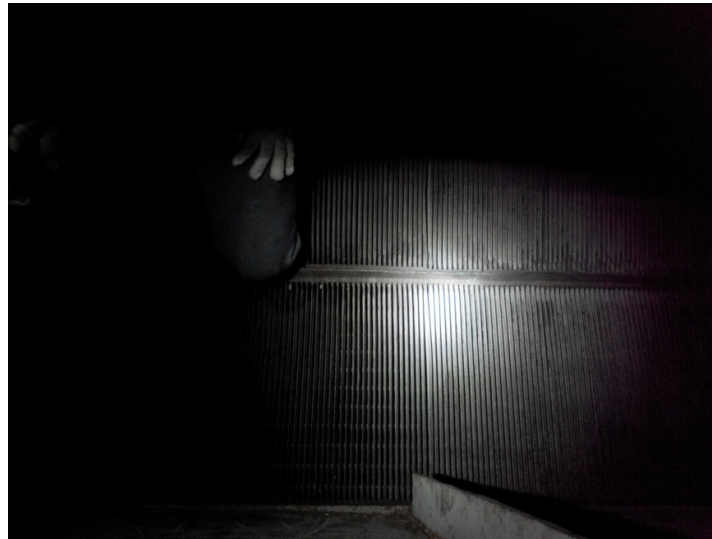
**Photo-1: Top of flue gas outlet side of one of the modules.**

Inspection using ultraviolet light was carried out from both flue gas inlet and outlet side of Air Preheater. Leakages were identified in all modules in flue gas inlet and outlet side. However, number of leaky elements on flue gas outlet side was less as compared to flue gas inlet side.

Close visual inspection of leaky elements revealed that seal welding of elements was opened up. Few plates of the element were found torn out from its seal weld. The maximum length of torn out plate was @ 125 mm and it had gone to a maximum depth of @ 20 mm.
