Weld defects analysis of 60 mm thick SS316L mock-ups of TIG and EB welds by Ultrasonic inspection for fusion reactor vacuum vessel applications

Ramesh Kumar Buddu, Shamsuddin Shaikh, P.M. Raole, B Sarkar
FRMDC Division, Institute for Plasma Research, Bhat, Gandhinagar-382428
brkumar75@gmail.com; buddu@ipr.res.in

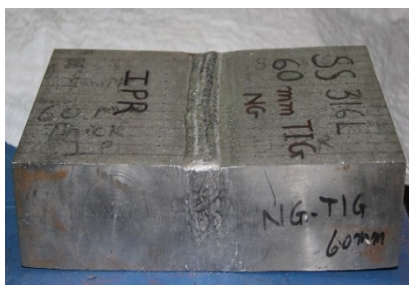
Fig.2(a) TIG weld sample (macro)

The final weld samples with narrow groove V joint fabricated by multipass TIG process and two pass EBW are shown in Fig. 2(a) and 2(b) for reference. The samples fabricated have analyzed for the weld bead profiles by macroscopic examinations and found as weld bead of ~ 15 mm for TIG welded samples and ~ 2.5 mm for the EBW samples. The weld cross section macro images are shown in same Fig 2(a)& (b)for reference. The weld cross sections revealed full weld penetration without any noticeable imperfections/discontinuities as per visual inspection. In order to check the weld quality throughout the welds, detailed NDT inspections have been carried on the fabricated weld samples.

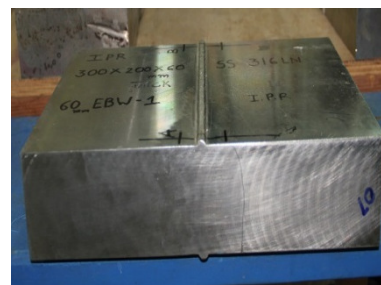
Fig.2(b) EBW sample(macro)

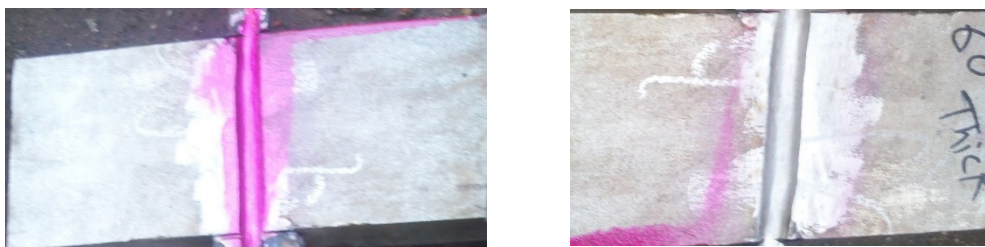
Fig. 3 LP tests on 60 mm TIG welds (no cracks/surface defects found)

No indicative weld defects are observed on the weld surfaces for discrete cracks/micro cracks or porosities. The examinations revealed that there were no any critical flaws like micro cracks or discontinuities on top of the weld bead surfaces across welds. Fig. 3 is shown for the reference of TIG weld sample subjected to LP test and no visual imperfections are noted.

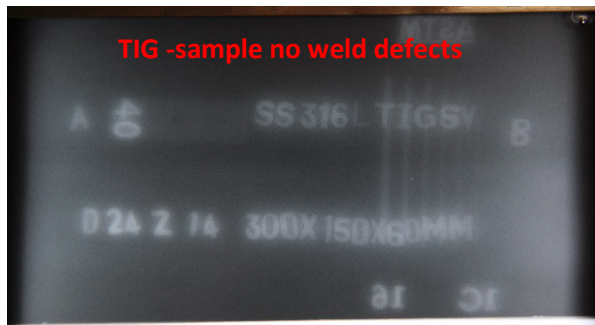
Fig.4(a) X-ray radiography of TIG weld

welding have been found to be free from any visible weld defects like porosity, lack of penetration or lack of side wall fusion defects. As the thickness is higher, the intensity of the X-ray source requires high to get the proper penetration for the results. The examined images are shown in Fig.4(a) for reference for TIG welds and it has shown no observation of the any weld defects present. And as shown in Fig 4(b) for EBW sample, there is no noticeable weld defect present in the weld zone.

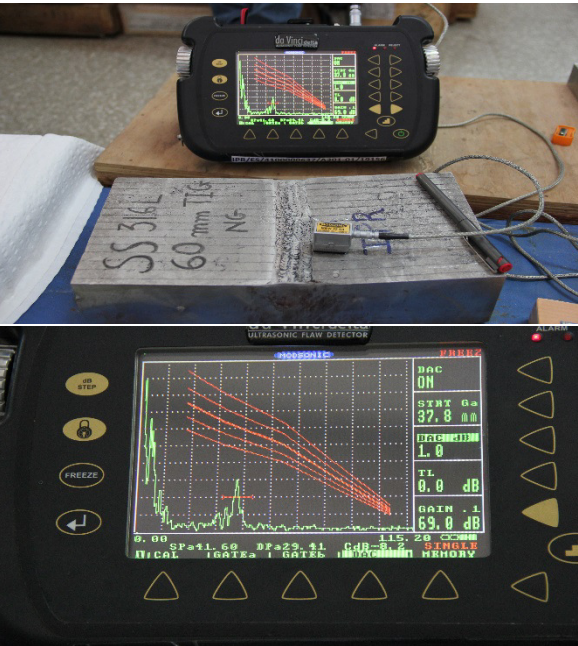
Fig.6. TIG weld sample defect (Porosity)

A-scan ultrasonic method is used to examine the weld samples of both types. In TIG weld sample, angle probe has shown the response of defects at different locations. As shown in Fig.6, the gas porosity was observed at depth of 29.41 mm and the defect signal is below the DAC curve indicating, size of the defect is less than 2 mm diameter. The same was not revealed by the X-ray radiography examination. Similarly in case of EBW coupons it was observed that gas porosity at a depth of 34.07 mm and is shown in Fig.7. The same was not revealed by X-ray radiography in such higher 60 mm EB weld joint. This show the strength of the ultrasonic technique potential application of the thicker steel welds for structural components in in advanced fusion reactor fabrication inspection methods. Further some work is needed to establish in the development of this technique to deal with the sub size weld defects below ~ 0.5 mm range in competent to the higher advanced phased array ultrasonic expensive technique implementation.
