Case Histories in Ultrasonic Testing.

V Prasad, M. M. Gautam, C. Satheesh, and P.V Varde

Research Reactor Services Division
Bhabha Atomic Research Centre
vprasad@barc.gov.in

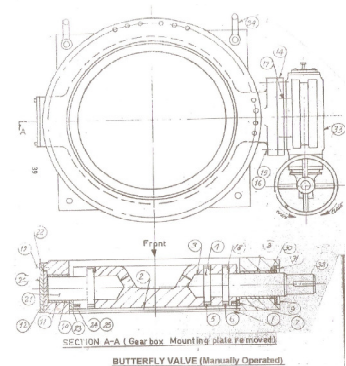
Four stainless steel butterfly valves are flange type and size of 450mmØ with holes equally spaced for bolting to the mating flange (Fig. 2). The seat ring is secured to the valve body and sitting surface is machined at an angle allowing the disc to swing through its arc. The valve disc is of slab type. It is secured to the shaft by three shear pins- two in the drive shaft and one in the non drive shaft. The drive shaft extends from the body and this fitted with a key to suit the drive from the driving unit. The valve is manually

operated with Fig. 2 Valve internals a gear and chain wheel arrangement. Drive mechanism is provided with a mechanical

three position pointer and dial clearly showing the valve position as fully close at zero degree, fully open at 90 degree and intermediate positions.

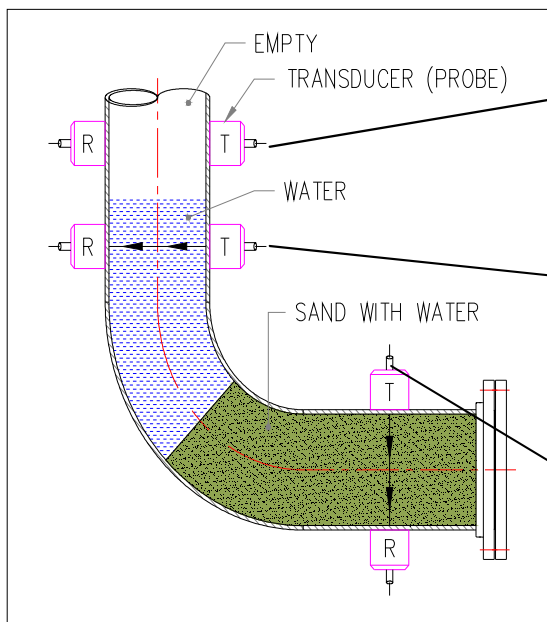
Fig.5 - Pipe filled with fine sand and water

Mock up trials were organised using Perspex shoes suitable for 40 mm Ø pipe and 16 mm Ø, 2.25 MHz sensor. An SS pipe segment of about one meter length closed at one end (Fig.-5) was utilised for calibration and trials along with M/s Panametric make 'Epoch-4' UT flaw detector. Both through transmission and pulse echo techniques were utilised during the trials in following three conditions;

a) Empty Pipe,
 b) Pipe filled with Water and
 c) Pipe filled with fine sand and water
 Empty pipe showed only wide banded echoes/noise signal (Fig 6 a). Water filled pipe showed the echoes at water path distance approximately 148 mm (Fig 6b). The pipe filled with fine sand and water showed echo amplitude of 15-20 % FSH (Full Scale Height) at 138 mm approximately (Fig 6 c).
